TECHNICAL BULLETIN 1.0

UNBONDED TENDON REPAIR SERIES

REPAIR OF DAMAGE AT LATERALLY DIVERTED TENDONS

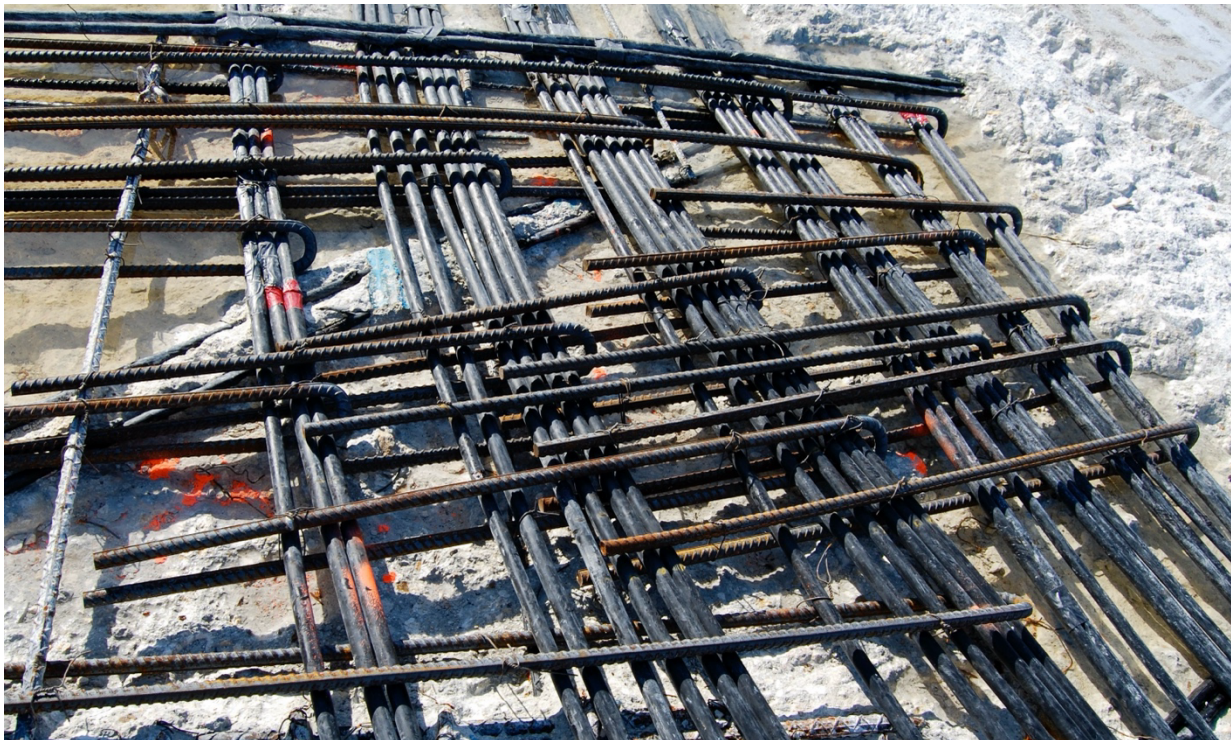
It has been observed that a common cause of tendons rupturing from a slab is due to a lack of adequate mild reinforcement in the form of hairpins that constrain the horizontal shear forces. This is particularly an issue with large groups of bundled cables but can develop with unreinforced single tendon sweeps. If it has been determined that insufficient hairpin reinforcement exists using non-destructive investigative means, such as X-ray or Ground Penetrating Radar, then this needs to be rectified as part of the overall repair strategy. While repair options may be considered, such as the installation of carbon fiber reinforcement to the slab surface, or vertically oriented rebar dowels along the tendon run, they should be thoroughly assessed by the structural engineer. It has been found that these alternatives often prove to be either structurally inadequate, or procedurally unsafe to be used. This often leaves the excavation of concrete from the lateral sweep area and replacement with rebar hairpins as the best alternative. It should be recognized that this repair option can be difficult because it will require the release of tension on all tendons with the repair location, and there may be large sections of concrete that need to be removed. Additionally, the installation of structural shoring in the areas that have temporarily lost post-tensioning support will need to be addressed.

Photo: Supplemental hairpin reinforcement added at banded tendon lateral sweep repair.

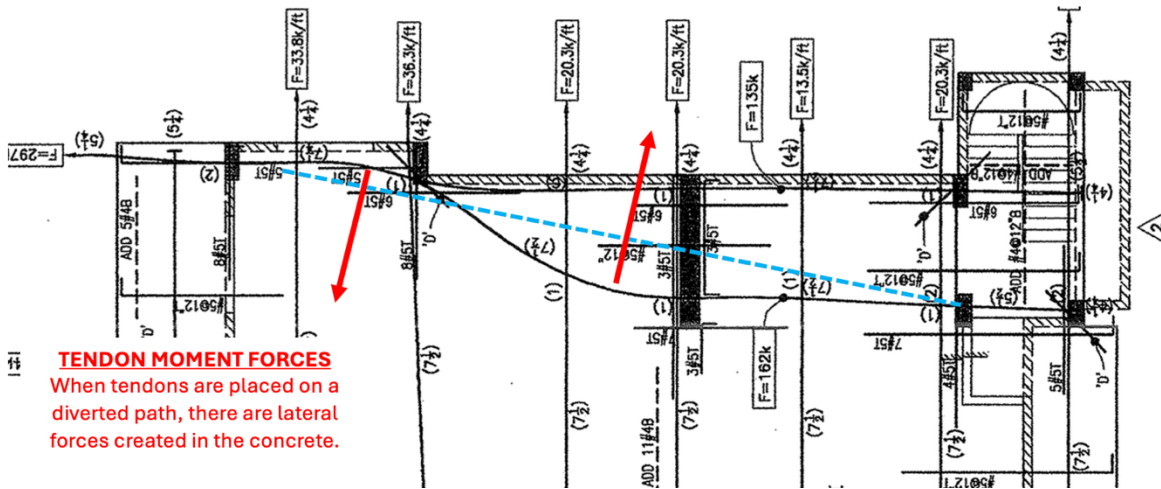
However, a tendons linear profile presents different challenges and is the subject of this discussion. When tendons are placed on a laterally diverted path, there are horizontal forces created in the concrete that must be recognized and accounted for, prior to undertaking any repair of the damaged area.

Image: Plan view sketch showing lateral tendon force in slab structure.

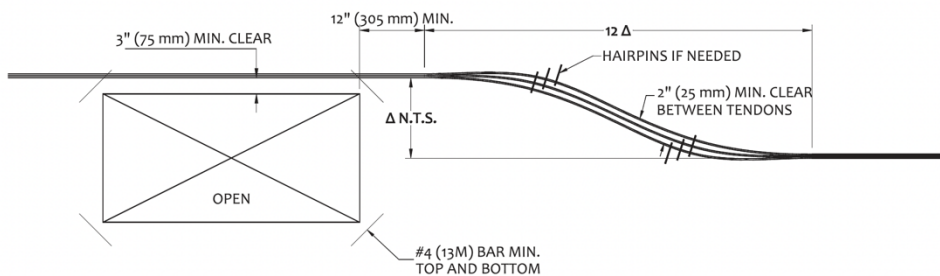
Fig. 4-6 — Typical detail of tendons deviating around an opening and tendon sweeps.

Prior to undertaking any repair efforts, it should be determined what post-tensioning exists within close proximity of the damaged area, and if these tendons also lack proper hairpin reinforcement, as they too could rupture from the slab during the repair. A failure of this type can present a significant safety hazard to anyone close by, as well as a potential loss of post-tensioning that can affect an entire tendon span. An examination of available structural and/or post-tension shop drawings can help identify the full extent of post-tensioning in the effected area. Additionally, it can be helpful to x-ray the areas around the damaged slab in order to confirm the existence and location of all post-tensioning and hairpin reinforcement that will play a factor in the repair.

Image: The Post-Tensioning Institute recognizes the need for additional mild reinforcement in lateral sweeps.

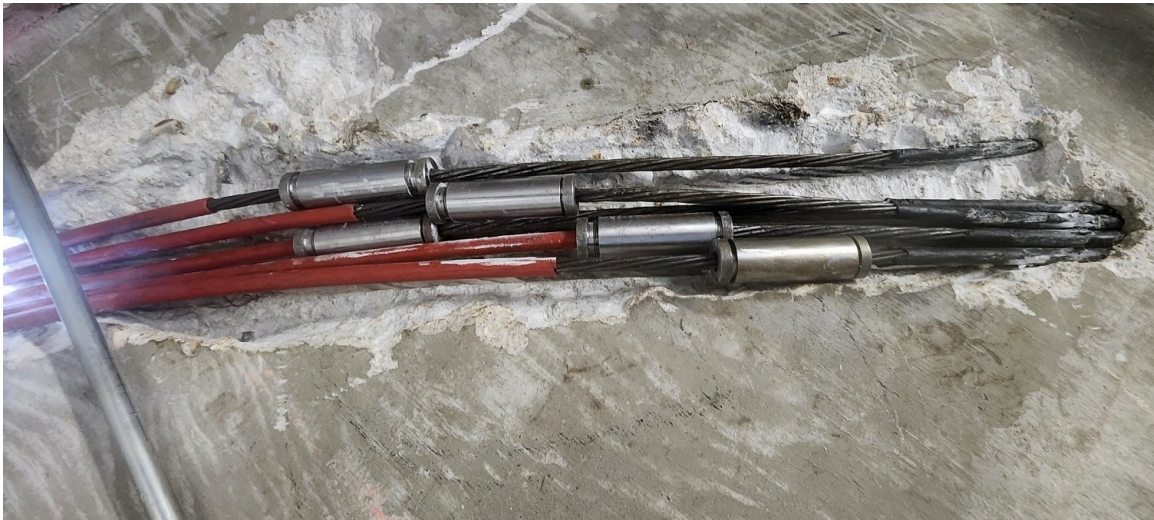
An issue that should be avoided is the installation of splice couplers at a location that places high bending stress on the hardware. These parts are designed to handle high tension loads that run in a straight unidirectional manner through the part. When they are subjected to off-center eccentric tension loads, it can overstress the hardware and result in a sudden and catastrophic failure of the splice coupler. It is strongly recommended to avoid the installation of splices within an area of lateral tendon displacement. Instead, they should be located where the tendons have returned to a straight configuration.

Photo: Installation of these splice couplers within the tendon sweep places an eccentric load on the hardware.

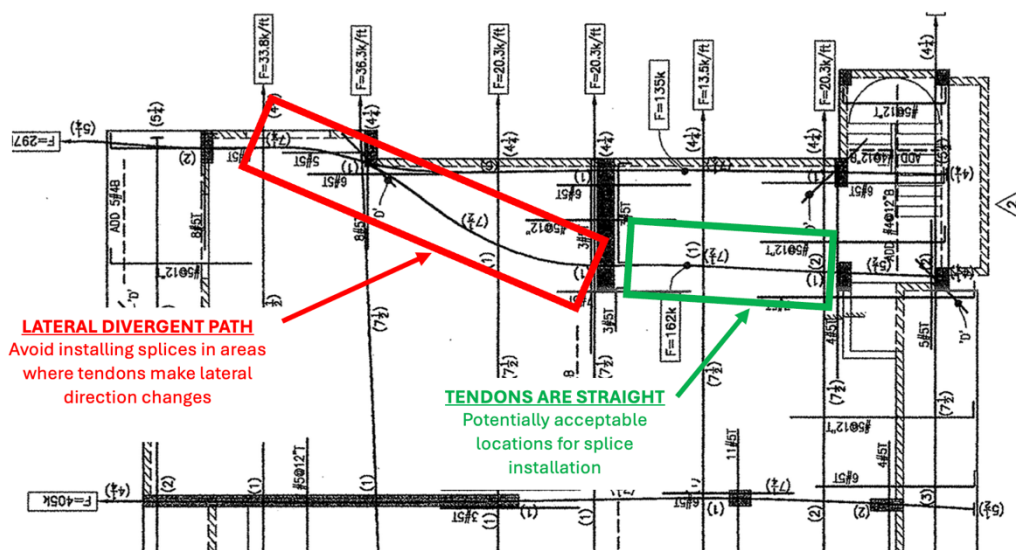
Image: Plan view sketch shows locations to avoid when installing splice couplers.
