GENERAL Building Services TECHNICAL BULLETIN 1.0 UNBONDED TENDON REPAIR SERIES

August 2024 **REPAIR OF DAMAGE AT LATERALLY DISPLACED TENDONS**

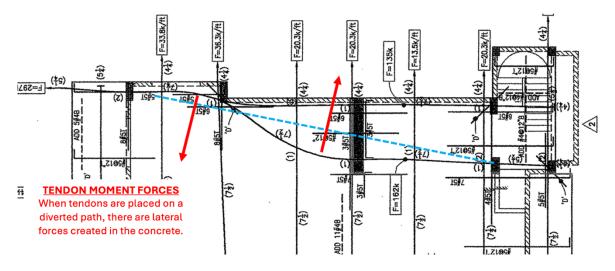
different challenges and are the subject of this discussion. When tendons are placed on a laterally diverted path, there are horizontal forces created in the concrete that must be recognized and accounted for prior to undertaking any repair of the damaged area.

Image: Sketch showing lateral tendon force in slab structure.

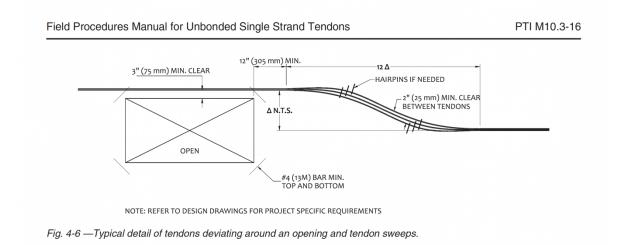
Prior to undertaking any repair efforts, it should be determined what post-tensioning exists within close proximity of the damaged area, and if these tendons lack proper hairpin reinforcement, as they too could rupture from the slab during the repair. A failure of this type can present a significant safety hazard to anyone close by, as well as a potential loss of post-tensioning that effects an entire tendon span. An examination of available structural and/or post-tension shop drawings can help identify the full extent of post-tensioning in the effected area. Additionally, it can be helpful to x-ray the areas around the damaged slab in order to confirm the existence and location of all post-tensioning and hairpin reinforcement that will play a factor in the repair.

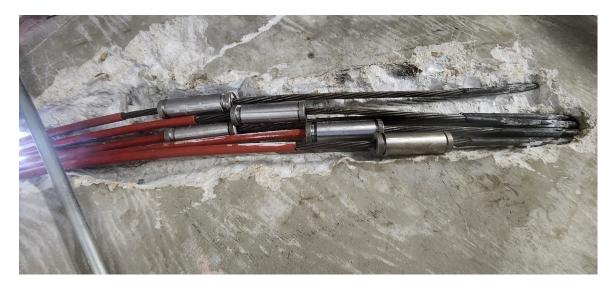
An issue that should be avoided is the installation of splice couplers at a location that places high bending stress on the hardware. These parts are designed to handle high tension loads that run in a straight unidirectional manner through the part. When they are subjected to off-center excentric tension loads, it can overstress the hardware and result in a sudden and catastrophic failure of the splice coupler. It is strongly recommended to avoid the installation of splices within an area of lateral tendon displacement. Instead, they should be located where the tendons have returned to a straight configuration.

Photo: Installation of these splice couplers within the tendon sweep places an excentric load on the hardware.

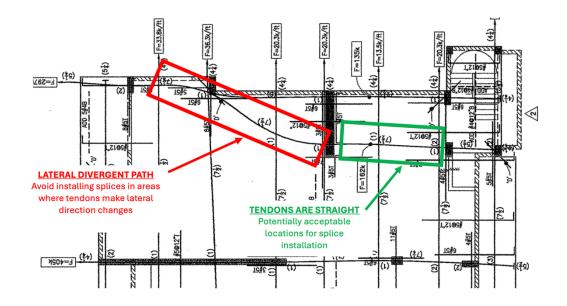
Image: Sketch shows locations to avoid when installing splice couplers.
