TECHNICAL BULLETIN 1.0

UNBONDED TENDON REPAIR SERIES

REPAIR OF DAMAGE AT LATERALLY DIVERTED TENDONS

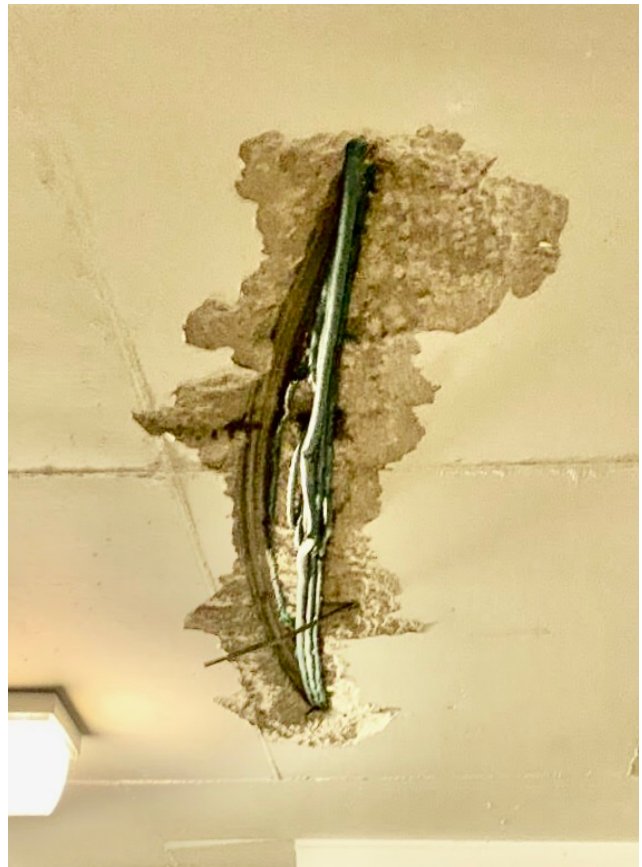
However, a tendons linear profile presents different challenges and is the subject of this discussion. When tendons are placed on a laterally diverted path, there are horizontal forces created in the concrete that must be recognized and accounted for, prior to undertaking any repair of the damaged area.
